Manhole Inspection Summary

Manhole # S25G__043MH

Insp Date: **4/2/08 10:00 AM**

Location Address: **1221 BALTIMORE ST**

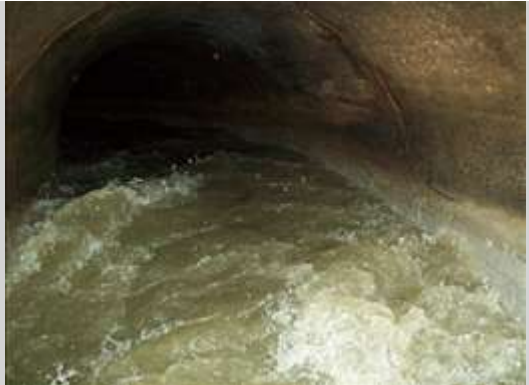
12 O'Clock Outflow

54 in. Circular Gravity Sewer
Pipe Out @ 12 O'Clock

Pipe Height: **55.2** (in.) Direct (Angled)
Pipe Material: **Concrete** ☐ Pipe Lined
Invert Depth: **22.50** (ft.) Flow Characteristics: **Fast**
Deposits: ☒ None ☐ Mud ☐ Sludge ☐ Debris ☐ Grease
Silt Depth: (in.) Deposits Extent:
Infiltration: **None** Pipe Seal Cond: **Sound**

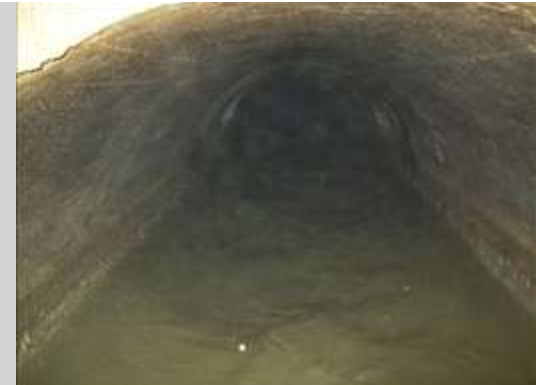
6 O'Clock Inflow

54 in. Circular Gravity Sewer

Pipe In @ 6 O'Clock

Pipe Height: **54** (in.) Direct (Angled)

Pipe Material: **Concrete** ☐ Pipe Lined

Infiltration: **None** Pipe Seal Cond: **Sound**
